**DEPARTMENT OF TRANSPORTATION****DIVISION OF ENGINEERING SERVICES**

Quality Assurance and Source Inspection

Contract #: 04-0120F4Cty: SF/ALA Rte: 80 PM: 13.2/13.9File #: 69.28**WELDING INSPECTION REPORT****Resident Engineer:** Pursell, Gary**Address:** 333 Burma Road**City:** Oakland, CA 94607**Report No:** WIR-001095**Date Inspected:** 15-Dec-2007**Project Name:** SAS Superstructure**OSM Arrival Time:** 1300**Prime Contractor:** American Bridge/Fluor Enterprises, a JV**OSM Departure Time:** 2330**Contractor:** Zhenhua Port Machinery Company, Ltd (ZPMC), Changxing Island **Location:** Shanghai, China**CWI Name:** Li Zhi Jiang**CWI Present:** Yes No**Inspected CWI report:** Yes No N/A**Rod Oven in Use:** Yes No N/A**Electrode to specification:** Yes No N/A**Weld Procedures Followed:** Yes No N/A**Qualified Welders:** Yes No N/A**Verified Joint Fit-up:** Yes No N/A**Approved Drawings:** Yes No N/A**Approved WPS:** Yes No N/A**Delayed / Cancelled:** Yes No N/A**Bridge No:** 34-0006**Component:** OBG and Tower Mockups**Summary of Items Observed:**

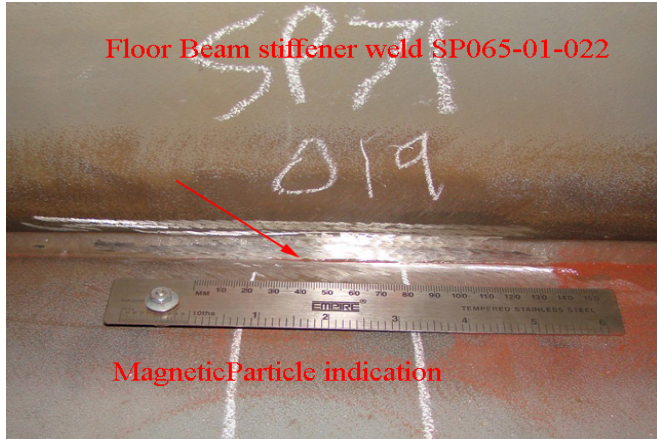
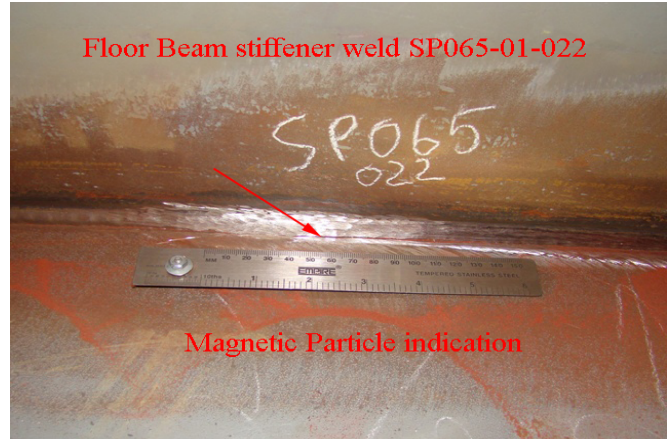
The QA inspector performed magnetic particle testing (MT) and visual inspection verification of floor plates SP065, SP071 and SP009 skin plates to T stiffeners weld numbers 13, 14, 15, 16, 17, 18, 19, 20, 21, 22, 23 and 24. The welds were examined using magnetic particle AC/DC yoke for 10 % of the weld length and 50% of the weld terminations. The QA inspector did not concur with the QC/NDT inspector's assessment. The following rejectable indications were observed.

- a) SP065-01-014, magnetic particle linear indication at the Y location of 400mm with a length of 10mm. The indication appeared to be incomplete fusion at the toe of the weld.
- b) SP065-01-016, visual indication at the Y location of 0mm with a length of 15mm and a depth of 2mm. The indication appeared to be undercut at the toe of the weld termination.
- c) SP065-01-022, magnetic particle linear indication at the Y location of 200mm with a length of 180mm. The indication appeared to be incomplete fusion at the toe of the weld.
- d) SP071-01-016, magnetic particle linear indication at the Y location of 0mm with a length of 300mm. The indication appeared to be incomplete fusion at the toe of the weld.
- e) SP071-01-020, magnetic particle linear indication at the Y location of 230mm with a length of 75mm. The indication appeared to be incomplete fusion at the toe of the weld.

The following digital photographs below illustrate the indications observed on the floor beam stiffeners.

The above indications were brought to the attention of ZPMC personnel Ken Zang working in the bay at the time. The indications were verified by ZPMC QC CWI Xu Xian Ping. The magnetic particle indications were removed by grinding. After the grinding was complete the welds were examined by magnetic particle testing. No relevant indications were observed. The undercut on weld SP065-01-016 was not repaired at this time.

The above issues were reviewed with Caltrans METS Task Leader Mr. James Cochran and METS recommends this issue to be addressed in a NCR.
